Salmon River Fishway Assessment Study

Campbell River Salmon Foundation: 09.cbr.06 Final Report Oct 14 2010

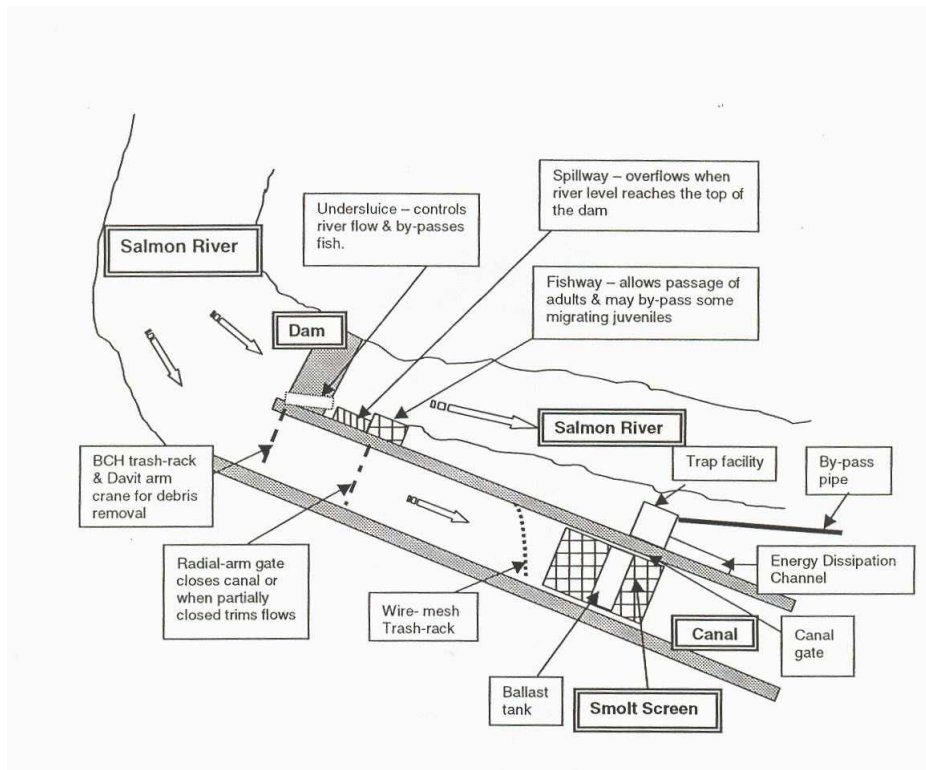
Figure 1. Schematic of Salmon River diversion structure (not to scale; from Hansen 2001).

Currently, fish must enter the small entrance (1.2m high by 0.4m wide) to the fishway slightly downstream of the dam face and sluice gate, which appears to be less attractive than the flows in the main river by the undersluice. When the canal is open, fish using the fishway must first maneuver up the ladder and then exit into the full flow of the diversion canal to continue to swim upstream. The trash-racks at the entrance of the fishway and the entrance to the diversion canal gather debris and can present an additional challenge for successful upstream migration. The migrating salmon appear to be attracted to the spills over the dam, or the flows through the undersluice, rather than the comparatively minor flow exiting from the fishway and thus tend to pool below the dam face rather than using the fishway (Figure 2). BC Hydro staff open the undersluice gate when they observe adult coho holding below the dam, and depending on the discharge

and head at the sluice the fish might then be able to travel upstream through the gate. Although both adult coho and smolts have been observed in the upper Salmon River, the success rate of adults navigating the dam structure is not known. Adult coho have been reported below the smolt screen in the diversion canal which eventually leads to the Campbell River system during periods where the radial arm gate is open and water is being diverted (M. Grant, BC Hydro, personal communication, 24 Sept 2008). This anecdotal information suggests that some coho are unable to continue upriver once they have entered the canal.

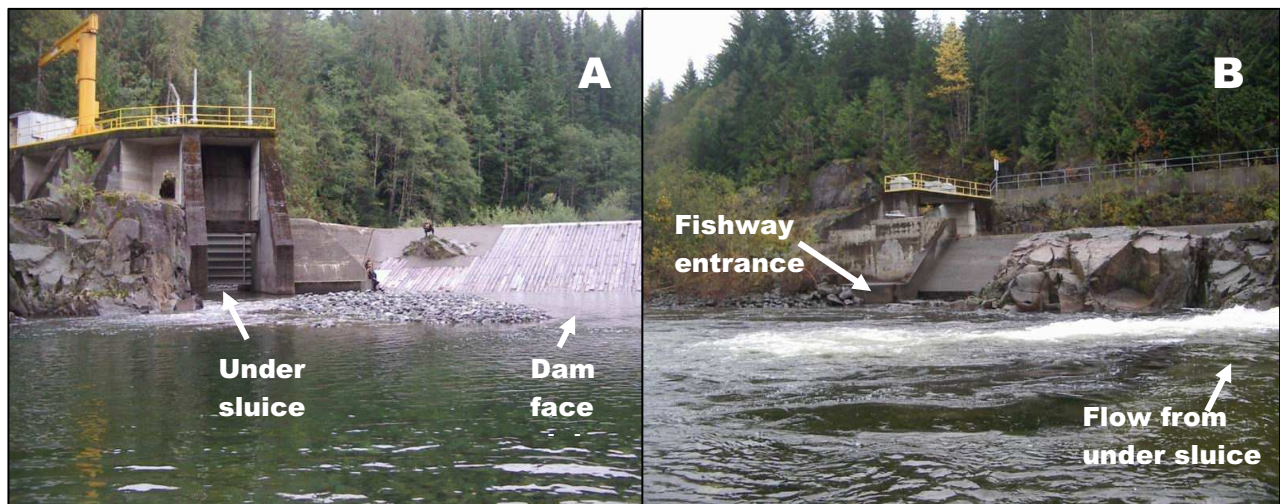
Figure 2. Salmon River diversion structure (photo courtesy of Shannon Anderson).

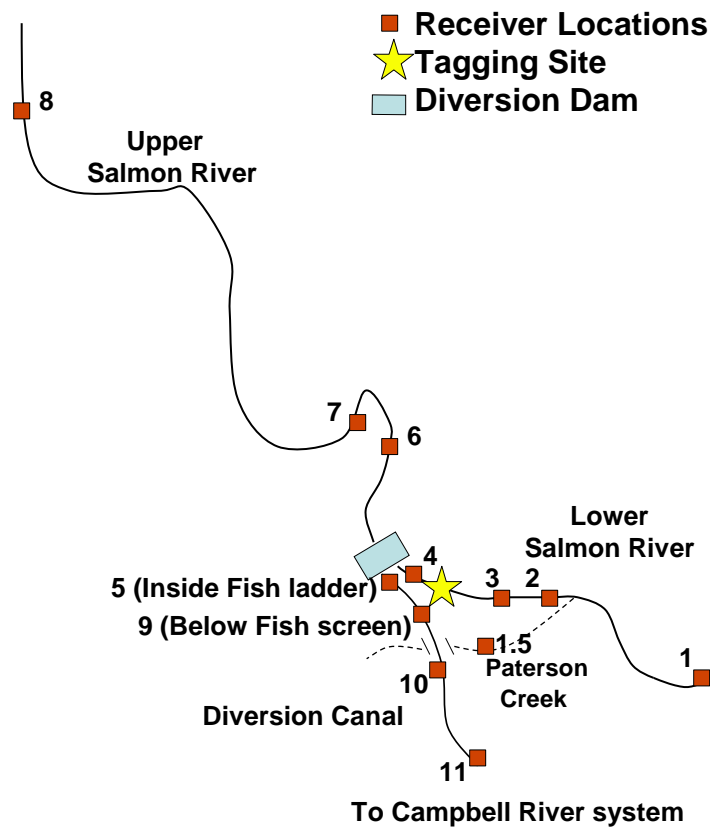
Figure 3. Schematic of acoustic receiver locations on the Salmon River (map not to scale). Receivers 1-8 were in the main river in the expected direction of travel for migrating adult coho; receivers 9-11 were in deployed in the diversion canal; and receiver 1.5 was deployed in Paterson Creek which runs under the diversion canal. The two tagging sites were very close together (<400 m) and are therefore represented as one.

To establish the pattern of movement, three acoustic receivers were installed upstream of the dam in the Salmon River, four in the Salmon River below the dam, two in the diversion canal below the smoltscreen, one in the diversion canal immediately above the smoltscreen and one in the fishway (cover photo and Figure 3). In addition to these 11 receivers, one receiver was placed in Paterson Creek which allows passage from the Salmon River to Paterson Lake at high flows. Unfortunately damage to the diversion canal prevented BC Hydro from diverting flow from the Salmon River to the Campbell system during the time the adult coho were migrating upstream.

The original design of the array was similar to the layout of the 2008 study with a few alterations:

- 1) A fourth receiver was added in the main river 5.75 km below the dam, close to Marilou Lake at the site of the Memekay main logging road Salmon River bridge.

- 2) An additional receiver was installed in the diversion canal by the bypass pipe that returns fish to the Salmon River.
- 3) One receiver was installed in Paterson Creek, a coho tributary ~ 1km below the dam.

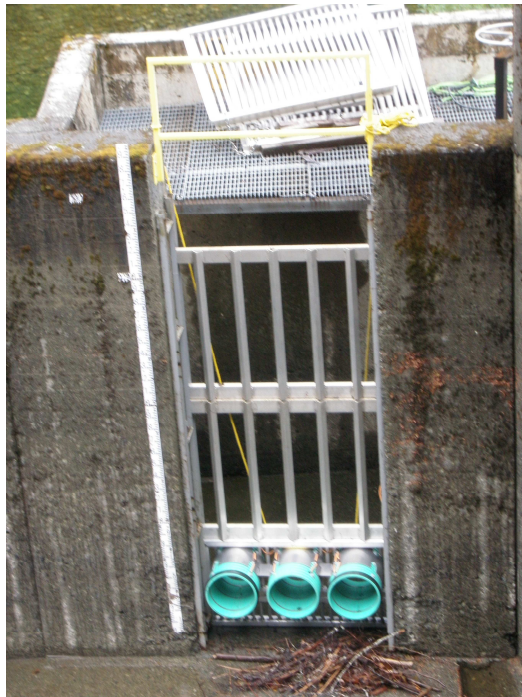
Figure 4. The exit of the fishway with the resistivity counter in place and original trash rack panels in place above counter. The modified trash-rack panels designed to prevent passage of fish above the counter can be seen lying on top of the fishway.

- 4) InStream Fisheries Research Inc replaced the normal trash rack/gate at the top of the fish way with a resistivity counter and panels with narrower openings to ensure fish would only pass through at the counter at the bottom of the fish way rather than being able to pass at any depth (Figure 4). In 2008, an acoustic receiver had been placed in one of the lower chambers, but anchoring proved difficult and this receiver had torn loose. In 2009 the receiver was attached to the resistivity counter inside the fishway, and when InStream removed the resistivity counter it was placed on the trash rack.

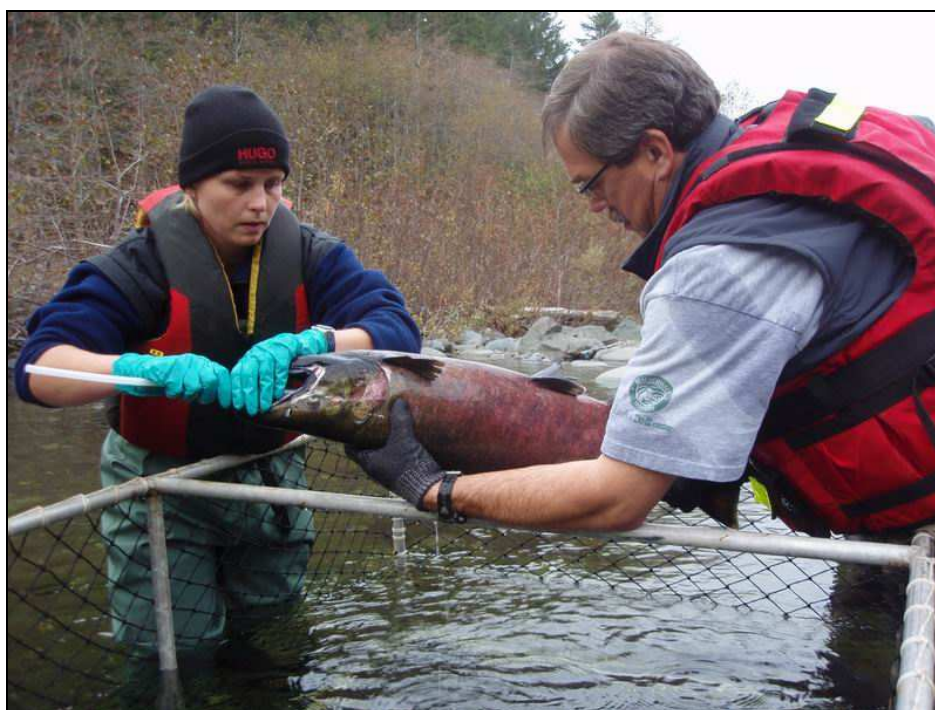
Figure 5. Gastric implantation of acoustic tag in adult coho by Heidi Lydersen (Kintama Research) and Barry Peters 2008 (DFO; Photo courtesy of Mainstream Biological Consulting Inc).

To minimize fish handling, tagging was done in the river alongside the broodstock bags. Individual fish were lifted out of the water, turned belly-side up, and the V13-1L tag was quickly inserted into the stomach using a food grade, flexible plastic tube and plunger (Figure 5). Once the tag was inserted, the fish were put into a holding bag to monitor for tag regurgitation. The tagging procedure took less than one minute per fish and included data gathering (length and sex) and scale samples.

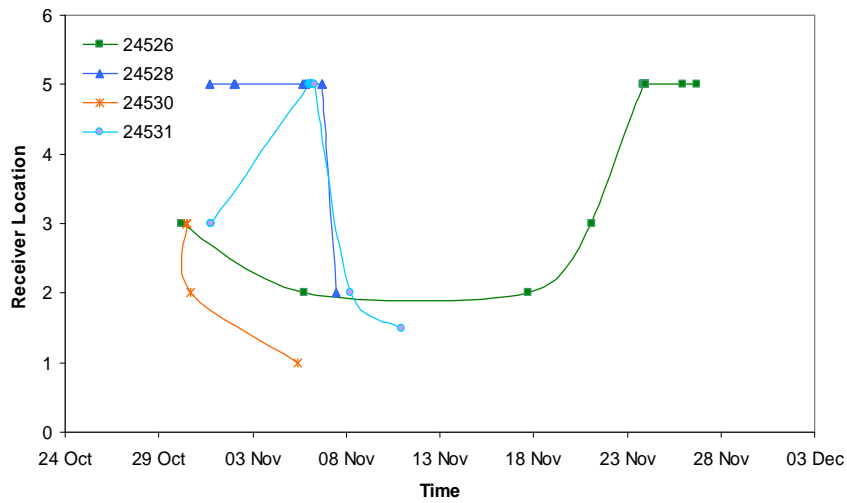
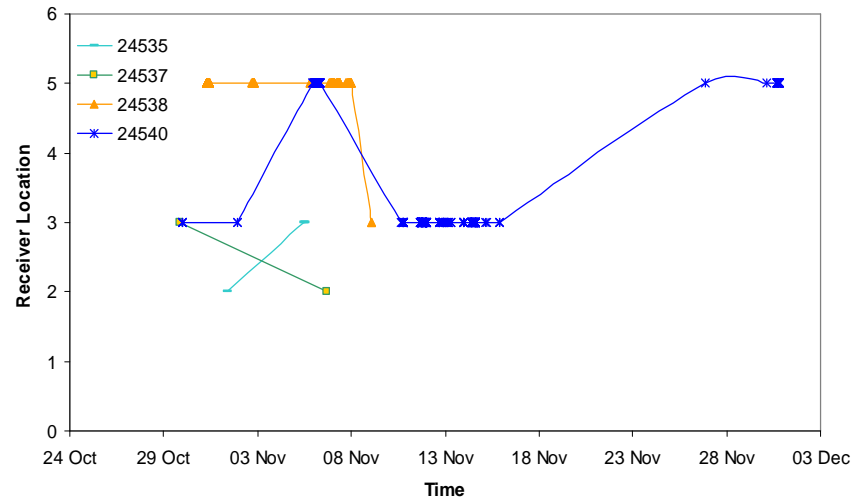
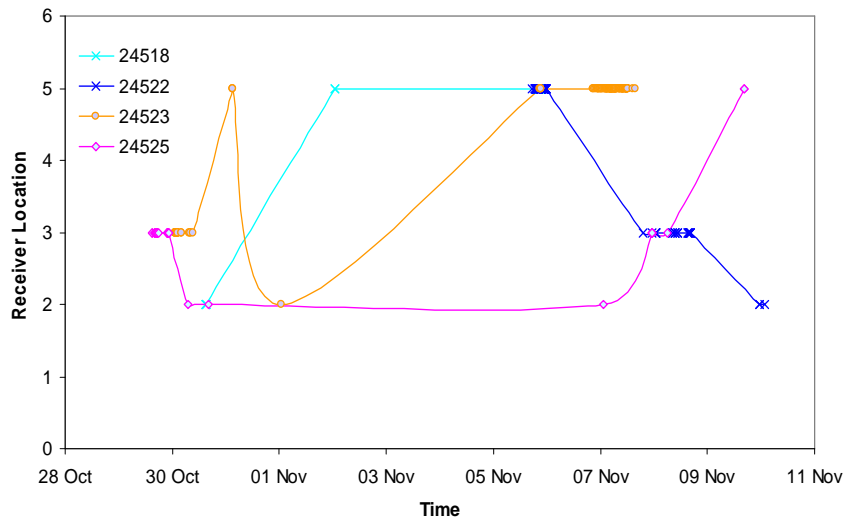
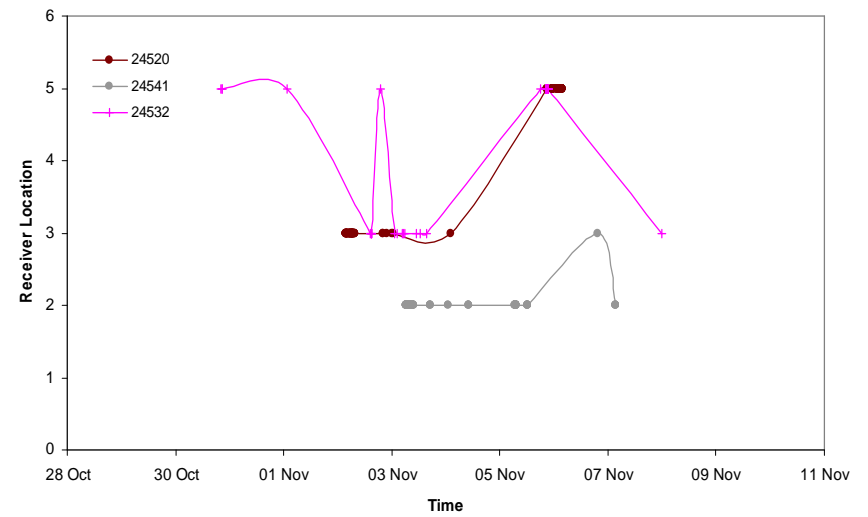
Figure 6. Movement over time of 15 individual fish in dam area. Fish which were only heard on one receiver are excluded from the graphs but identified in Table 1. Receiver locations can be seen on cover photo and Figure 3.

During the study, 16 (53%) coho migrated downstream and did not return (receiver 1, 2 or 3 was their last detection site) and one fish was last detected by the receiver located in Paterson Creek (receiver 1.5). Nine fish (30%) were last detected on the receiver in the fishway (receiver 5). No fish were detected above the dam or in the diversion canal. At the date of writing this report, receiver 4 has not been recovered. Figure 6 indicates the movement of the 15 adult coho tagged in 2009 that were detected on multiple receivers.

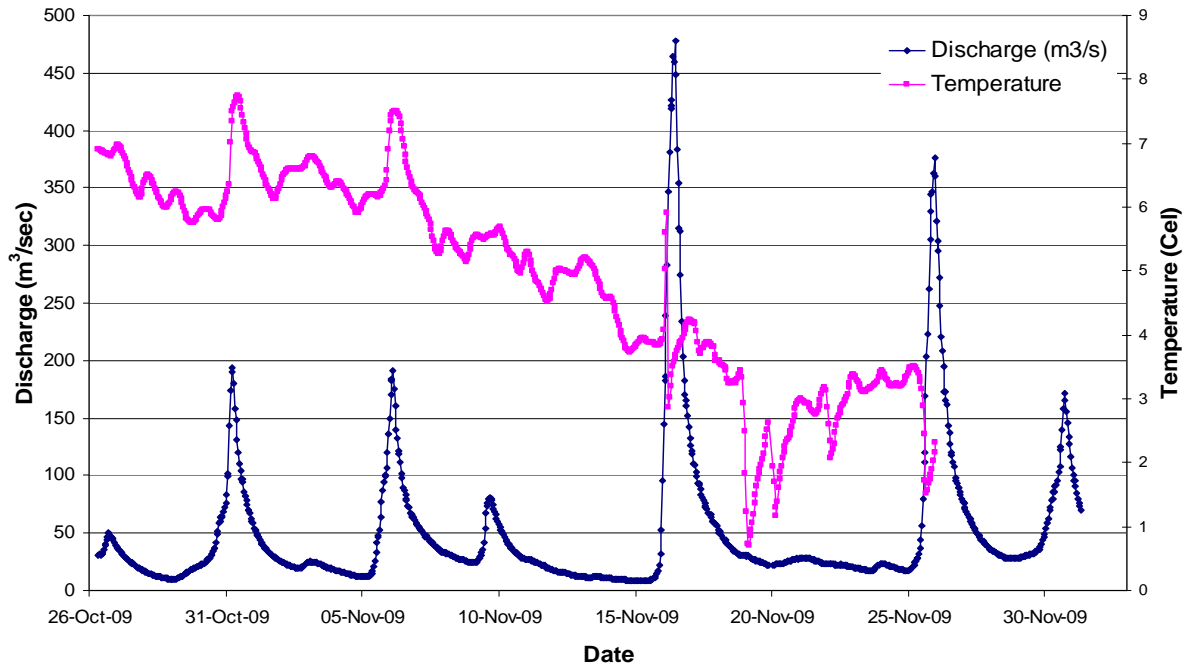
Figure 7. Flow (m³/s) and temperature (C°) in the Salmon River during the period coho were detected near the BC Hydro Diversion Dam. There is no temperature data after 26 Nov as the unit stopped functioning (0:04 UTC).

After the tagging event on Oct 28th, flows started to increase in the Salmon River. By Oct 31st 2010, the flow reached 193 m³/sec, but many tagged fish remained in the area. This is quite different from 2008, where after increased flows following tagging only two fish (of 14) remaining within the study area by day four, yet the 2008 flow in this period only reached ~30 m³/sec. It is interesting to note that the fish remained at the dam for much longer time periods in 2009 (higher flows) than in 2008 (lower flows).

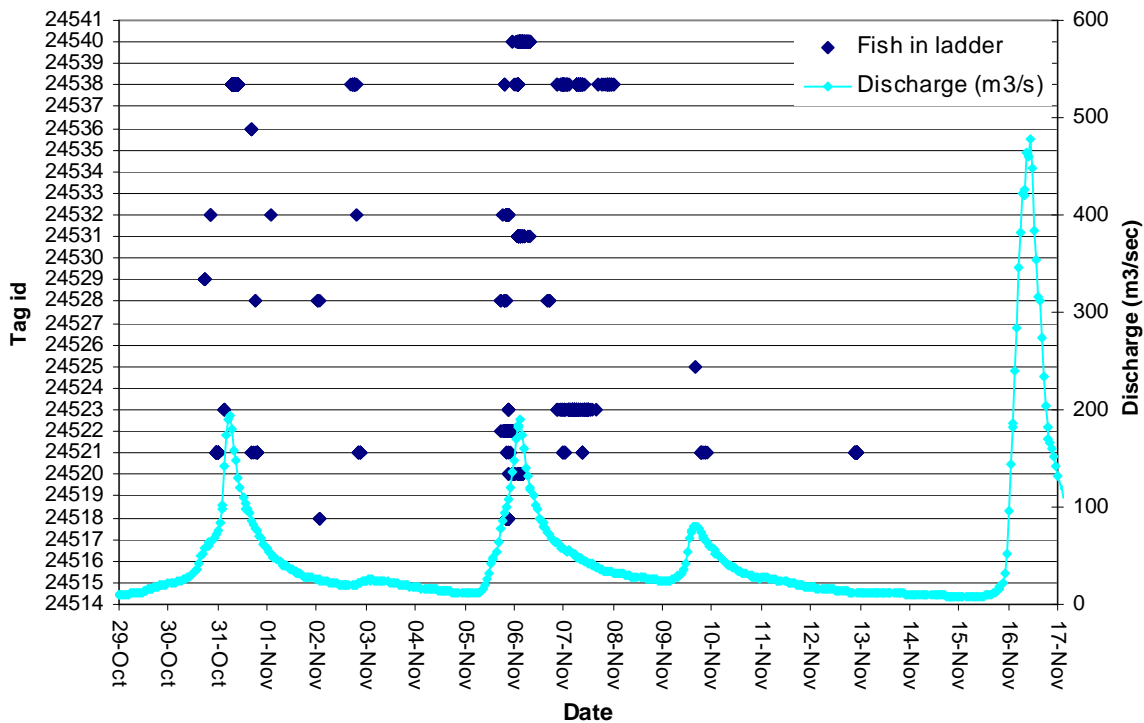
Figure 8. The presence of tagged fish in the fishway relative to the flow of the main river during the 2009 study period.
